Project Name:	Mountain Valley Pipeline	Inspector:	Matthew Grant		
Inspection Date:	Monday, December 7, 2020	Project Contact:	Brian Clauto		
Spread H: Montgomery	ST12180+00-12199+50 ST12117, ST12102+05-12098+50 ATWS 703, 704A, 1446, 1375 AR MN270.01, 274, 275	Weather:	Wet

FIELD INSPECTION PHOTO LOG

Project Name: Mountain Valley Pipeline

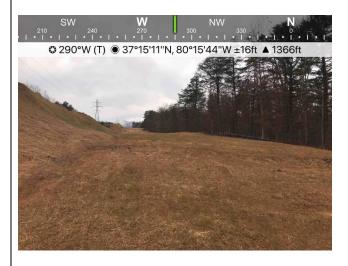
Figure 3: ST12180+00 area is stabilized
